***Impact Study for Generation
Interconnection Request
GEN – 2002 – 022***

***SPP Coordinated Planning
(#GEN-2002-022)***

System Impact Study for Generation
Interconnection Request
GEN-2002-022

Report Number: 2004-10921-1

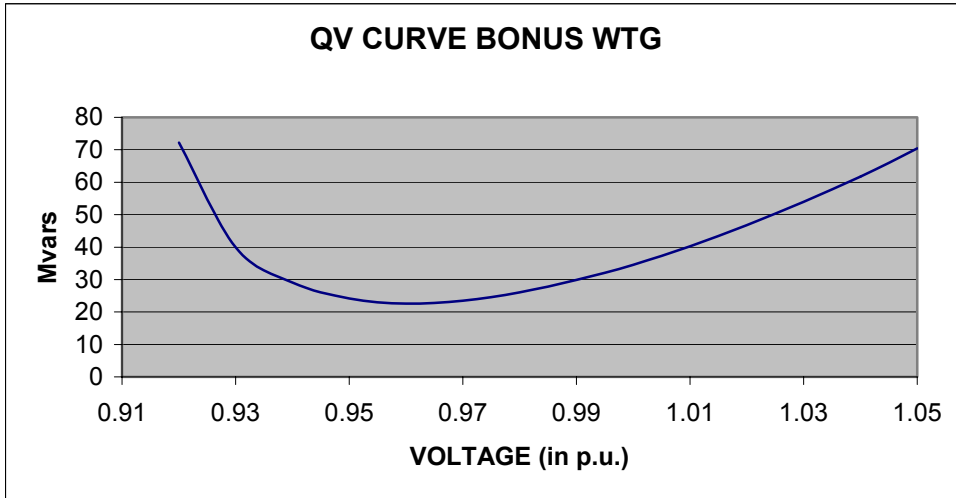
Fig 4.1 QV curve for GEN-2002-022 with Bushland-Potter Co 230kv line out of service

A QV analysis was performed on the Power flow case with Bushland-Potter Co. 230kV line out of service, which indicated a 22.6 Mvar deficit at the point of interconnection. Figure 4.1 shows the QV curve for the GEN-2002-022 Wind Farm at the POI. The wind farm has been modeled with enough capacitors on the 34.5 kV substation bus to give approximately unity p.f. at the point of interconnection with all lines in service.
