Impact Study of Limited Operation for Generator Interconnection

GEN-2011-054

April 2013
Generation Interconnection

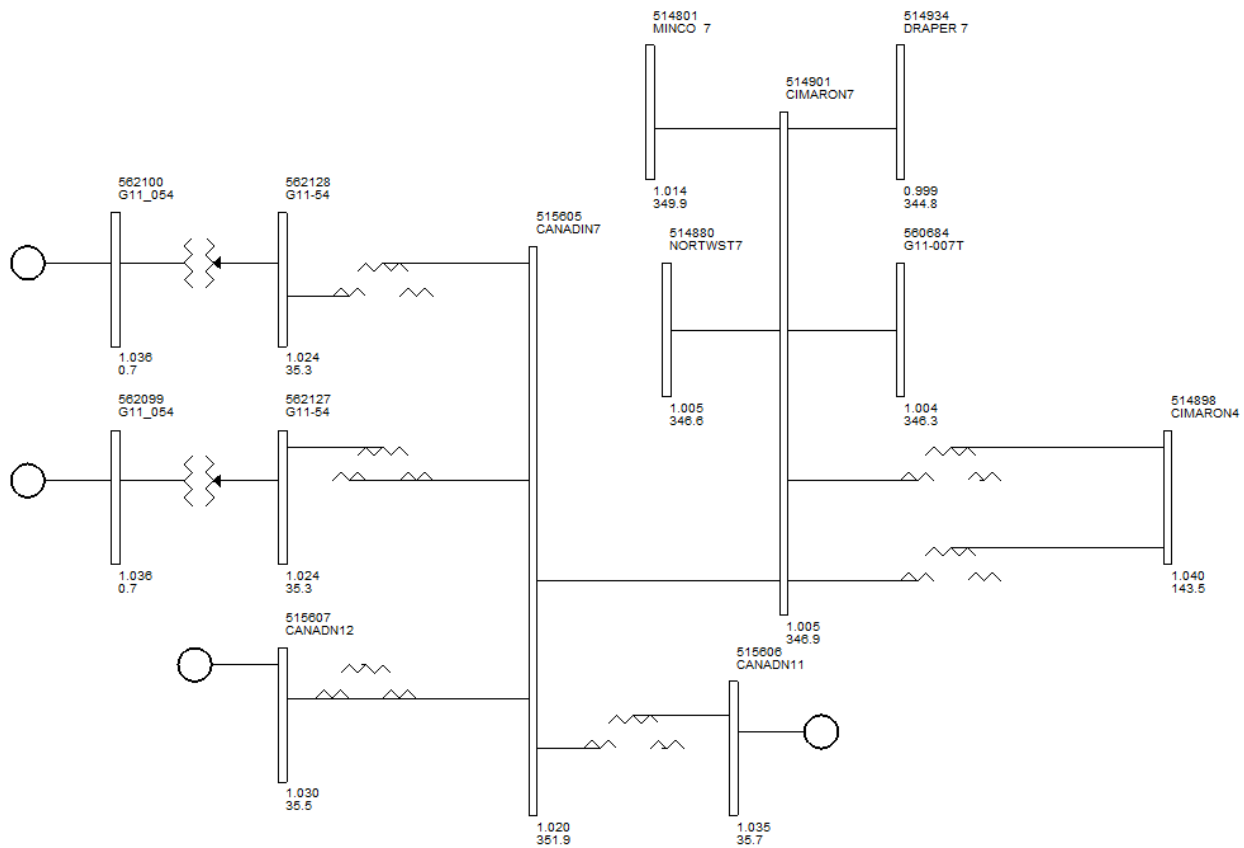
Figure 1: Proposed POI Configuration and Request Power Flow Model

The POI for GEN-2011-054 Interconnection Customer is at the Cimarron 345kV substation in Canadian County, Oklahoma. Figure 1 depicts the one-line diagram of the local transmission system including the POI as well as the power flow model representing the request.

GEN-2011-054 Interconnection Customer’s request to interconnect a total of 299 MW is comprised of one hundred thirty (130) Siemens SWT 2.3 MW wind turbine generators and associated interconnection facilities.
